**U.S. DEPARTMENT OF THE INTERIOR
BUREAU OF LAND MANAGEMENT
PALM SPRINGS-SOUTH COAST FIELD OFFICE**

**ENVIRONMENTAL ASSESSMENT
EA Number CA-660-05-28**

TITLE / PROJECT TYPE: OHV Route Restoration, Northern Kickapoo Trail

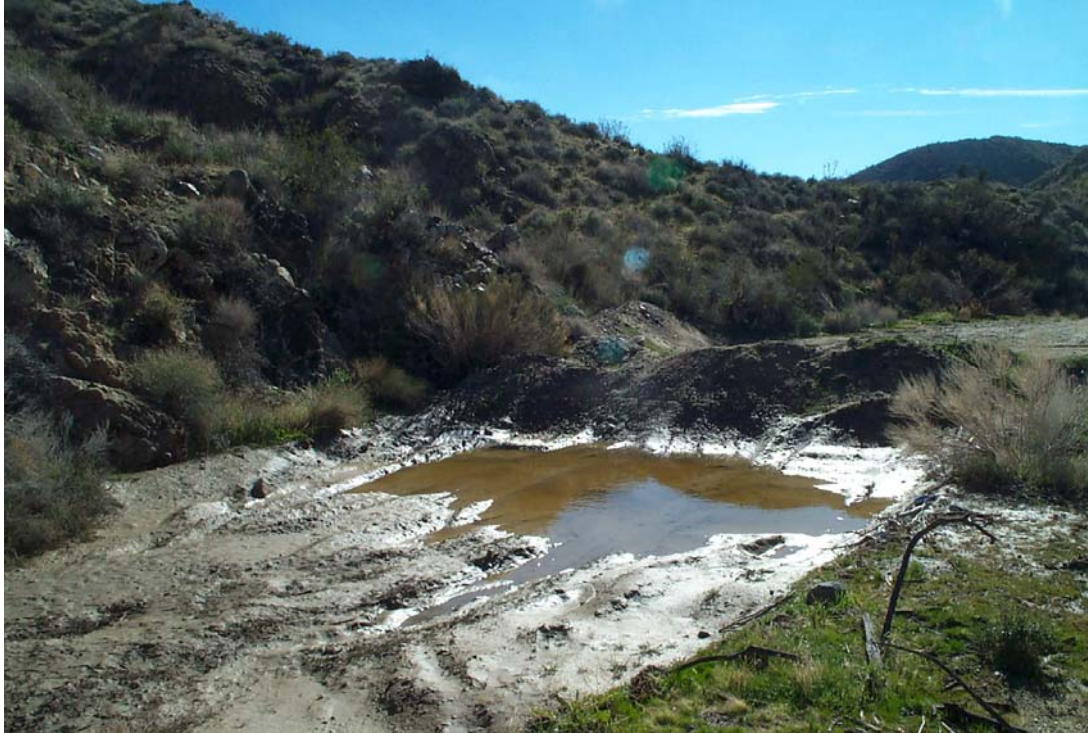
Figure 1. A pool of water caused by a large earthen berm after rain in Little Morongo Canyon. OHV are able to enter the canyon on the far right side of the berm.

The proposed rehabilitation sites include numerous side trails that braid in and out of the Southern California Edison (SCE) access road that runs from the Devers substation near Desert Hot Springs through lower Little Morongo Canyon and the upper unnamed canyon that connects with the Kickapoo Trail in Yucca Valley. This road is a popular touring road for off-highway vehicle enthusiasts as it is one of the few routes between the Morongo Basin and the Coachella Valley. The route is passable to 4-wheel drive vehicles all year and most 2-wheel vehicles during the dry season. The southern half of the road (contained in T1S R4E Section 36 and Sections to the south) has already been restored, as described in EA 660-05-03. This EA describes work proposed for the northern half of the road. The point where the Kickapoo trail diverges from the bottom of Little Morongo Canyon is on an inholding of private land. An unauthorized route (dubbed 'off CV005') travels from this point up Little Morongo Canyon to the Morongo Lakes area. Several other unauthorized routes which enter BLM land from this unauthorized route would also be restored. The first half-mile of 'off CV005' is on private land, the remainder is on public land. In FY 2004, large earthen berms were created in 'off CV005' near the point it enters public land, but the berms have not effectively blocked OHV access, and they have altered the natural flow of water in the canyon, causing pools to form, disturbing the distribution of sediment, and focusing the flow of water through breaks in the berm, causing high banks to form in the wash (see **Figures 1 and 2**). Furthermore, some of the berms have been washed out by water flow. Overall, they are not an effective barrier to vehicle travel in Little Morongo Canyon.

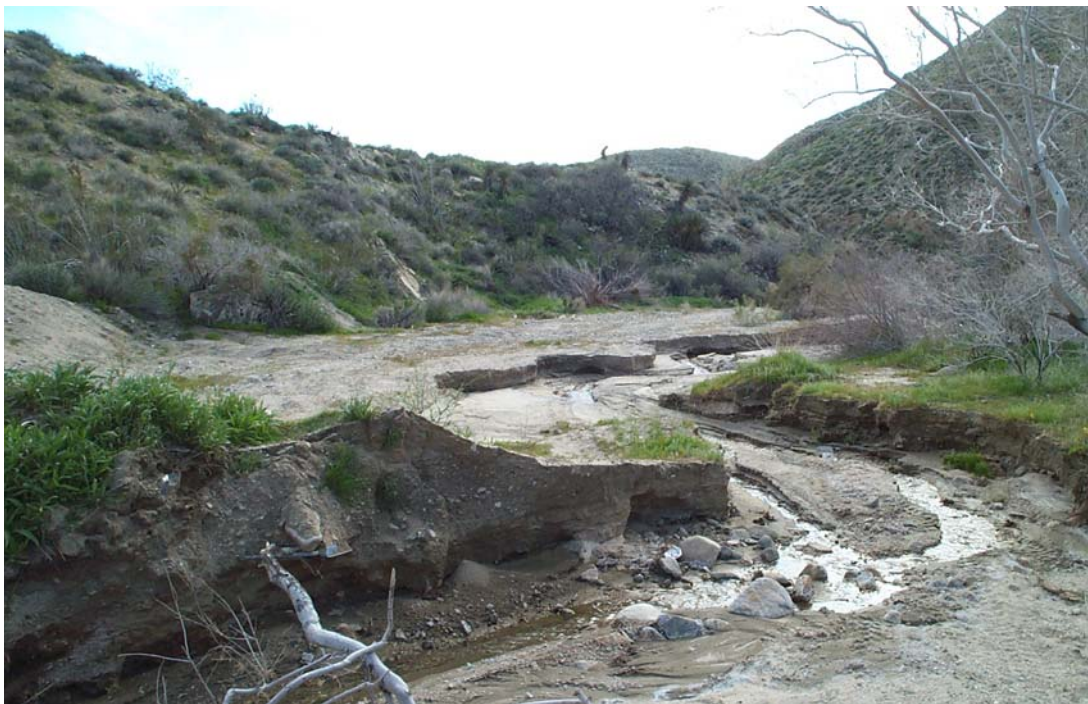
Figure 2 The far right side of the berm pictured in Figure 1, after the built-up water broke through the berm. Notice the steep banks caused by this channelization of the water flow.
